RADC-TR-77-410
Final Technical Report
December 1977

RELIABILITY STUDY OF DOPED ALUMINUM CONDUCTOR FILMS

Motorola Semiconductor Products Group

ROME AIR DEVELOPMENT CENTER
Air Force Systems Command
Griffis Air Force Base, New York 13441

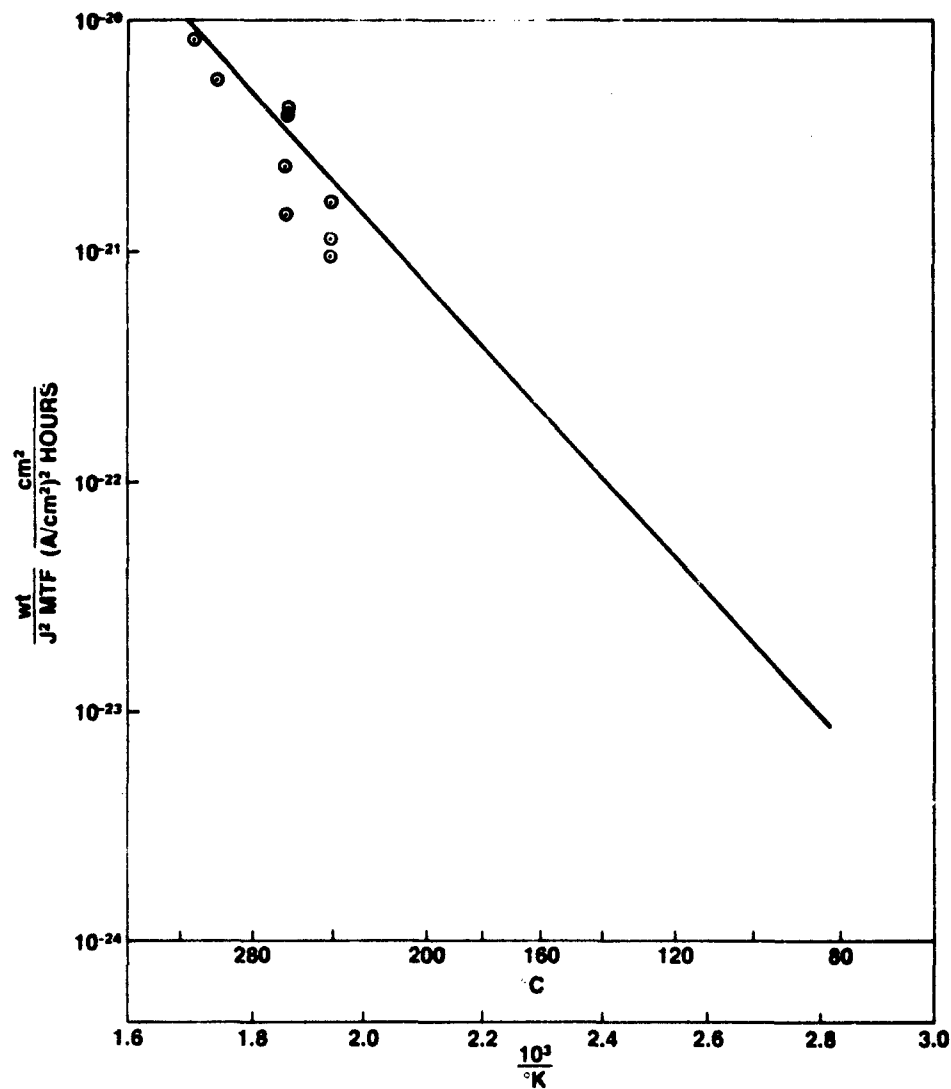
FIGURE 43. Al/Si ALLOY HIGH TEMPERATURE MEDIAN TIME TO FAILURE DUE TO VOID FORMATION RELATED TO FILM GEOMETRY, CURRENT DENSITY AND TEMPERATURE

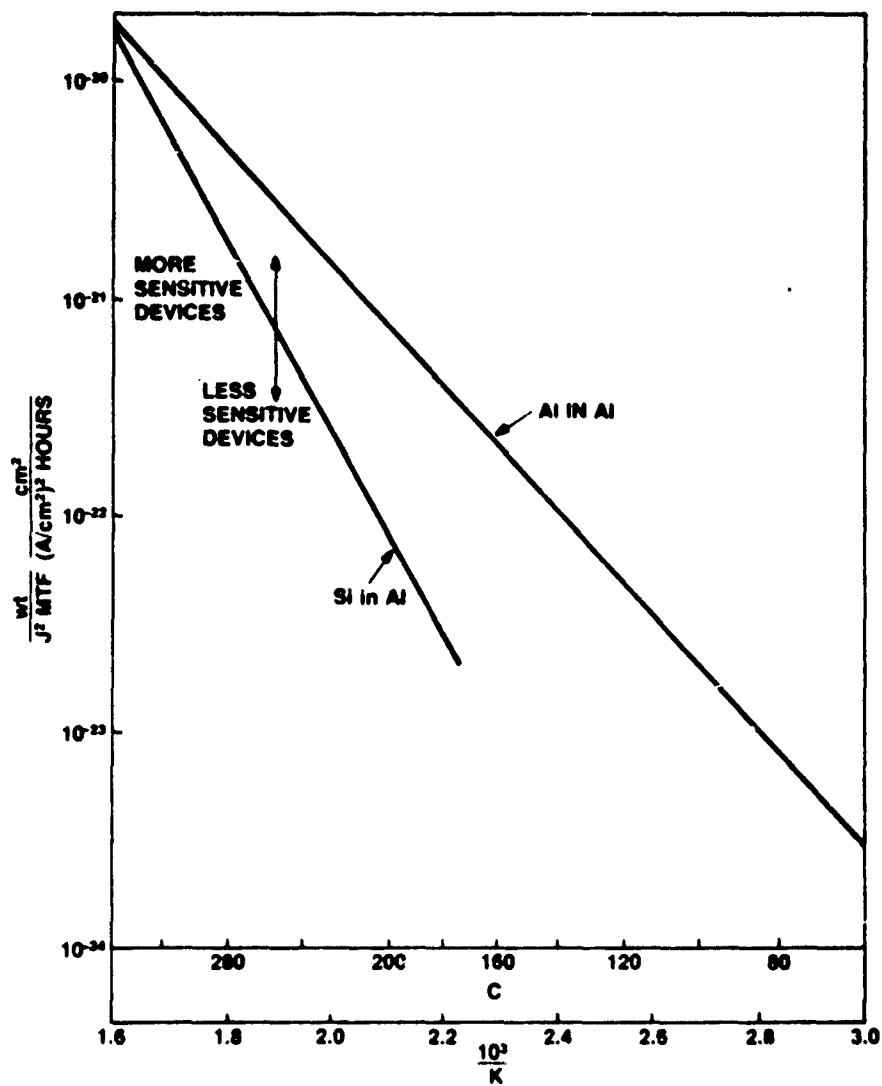
FIGURE 44. Al/Si ALLOY FAILURES DUE TO THE ELECTROMIGRATION OF Al IN Al AND Si IN Al

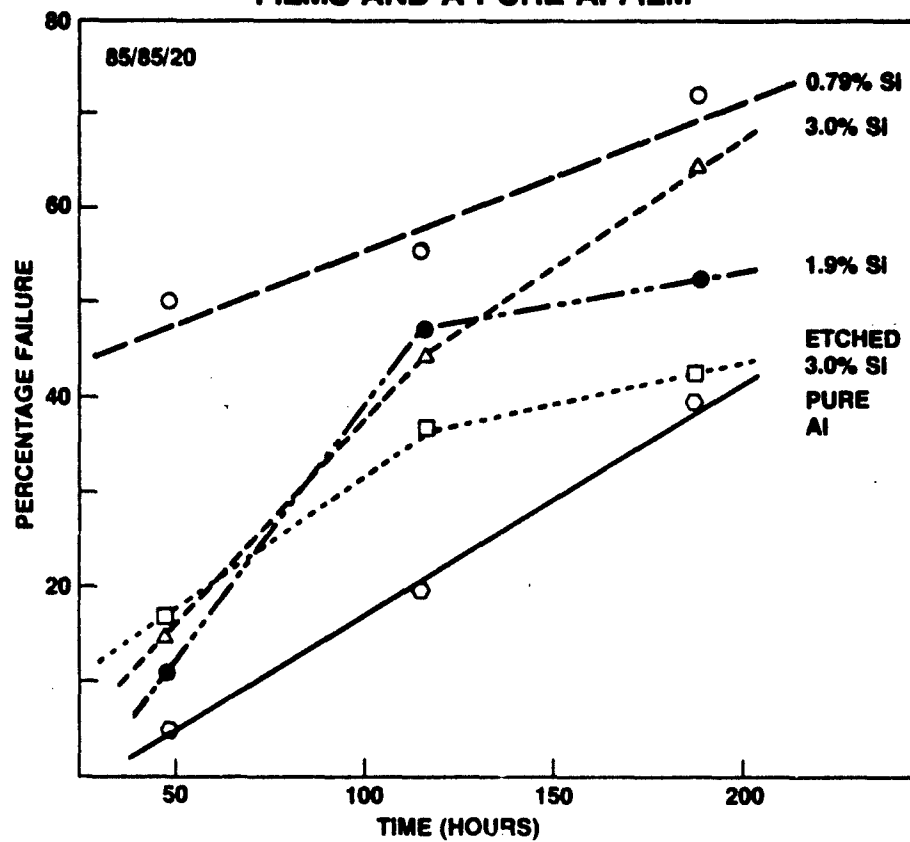
FIGURE 46. THE ANODIC CORROSION FOR Al-Si ALLOY FILMS AND A PURE Al FILM

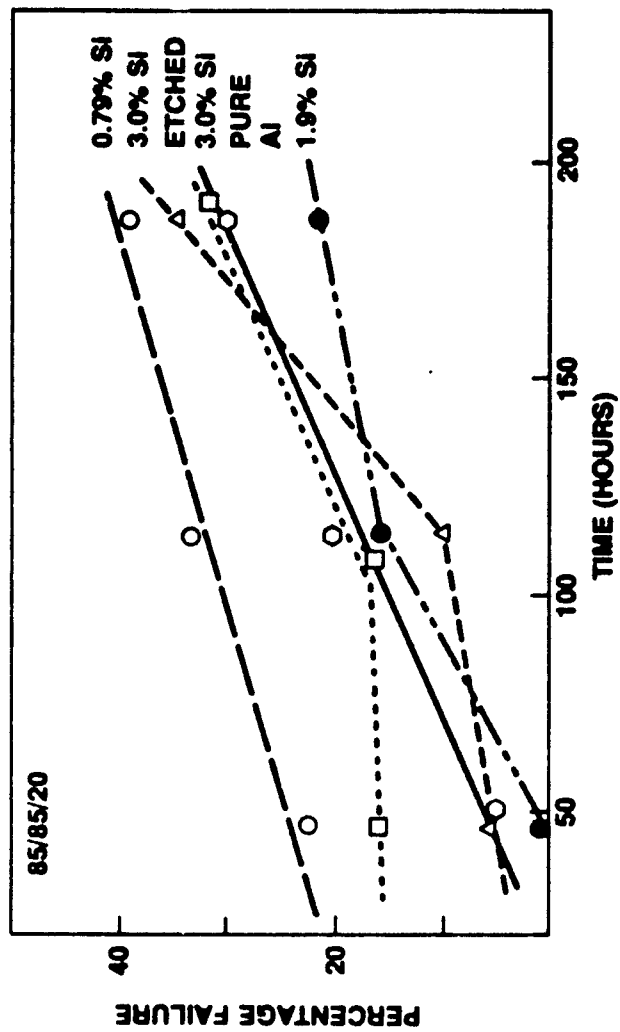
FIGURE 47. THE CATHODIC CORROSION FOR Al-Si ALLOY FILMS AND A PURE Al FILM

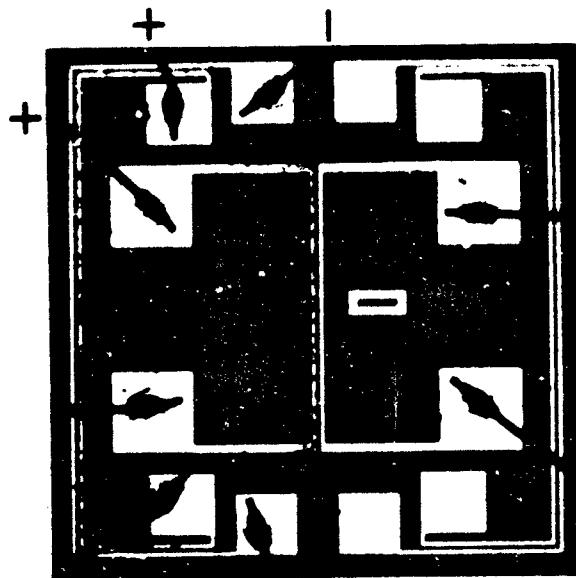
**FIGURE 48A. A TYPICAL Al-3% Si
SAMPLE SHOWING
CHARACTERISTIC
SPOTTY CORROSION
AT THE ANODE
STRIPES AFTER 180
HOURS AT 85/85/20.**

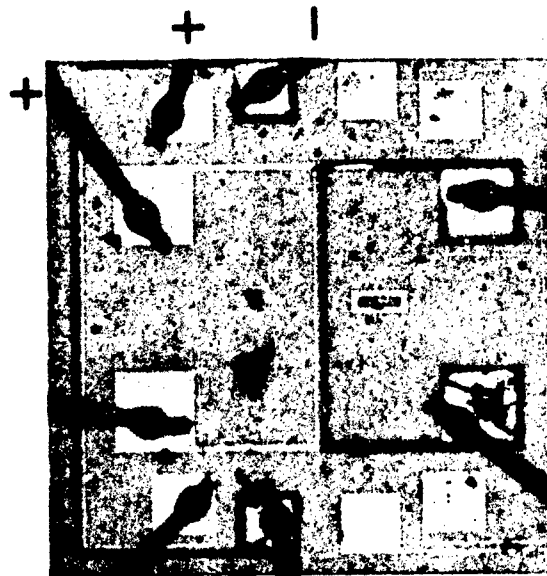
**FIGURE 50A. A PURE Al TEST
SAMPLE SHOWING
THE CATHODIC
CORROSION
CHARACTERISTICS
AFTER 180 HOURS AT
85/85/20.**

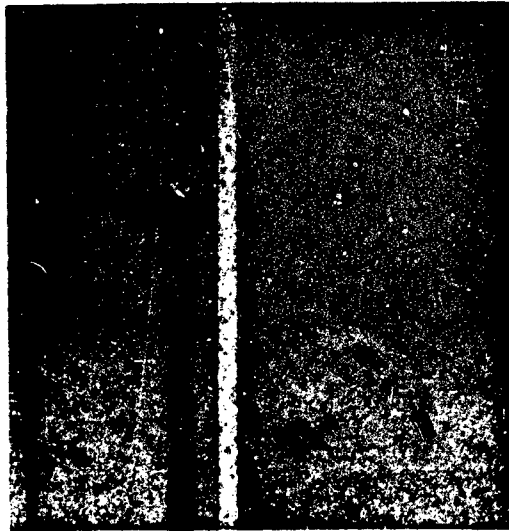
**FIGURE 50B. A HIGH
MAGNIFICATION VIEW
OF THE TOP PART OF
FIGURE 50A SHOWING
CATHODIC
CORROSION.**

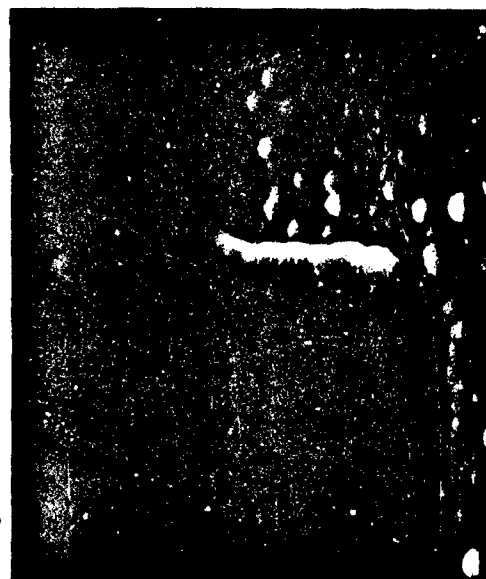
FIGURE 52. PASSIVATION GLASS CRACKS DUE TO THERMAL CYCLING

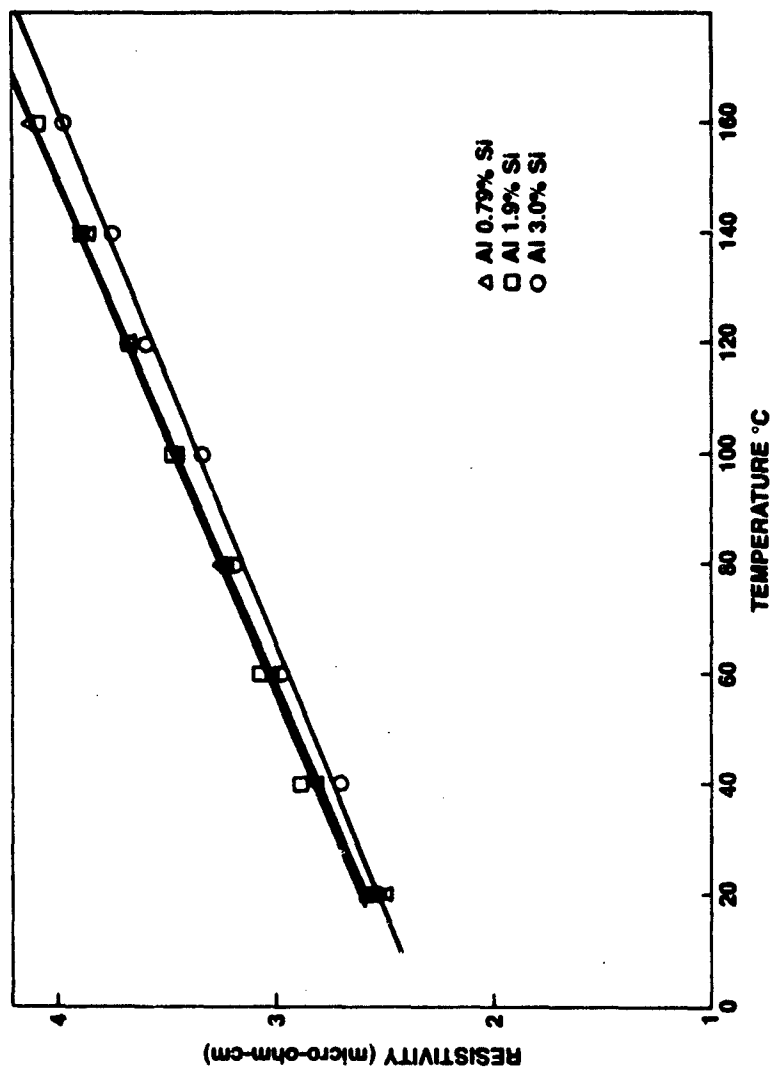
FIGURE 54. MEASURED RESISTIVITY OF THREE Al/Si ALLOY FILMS

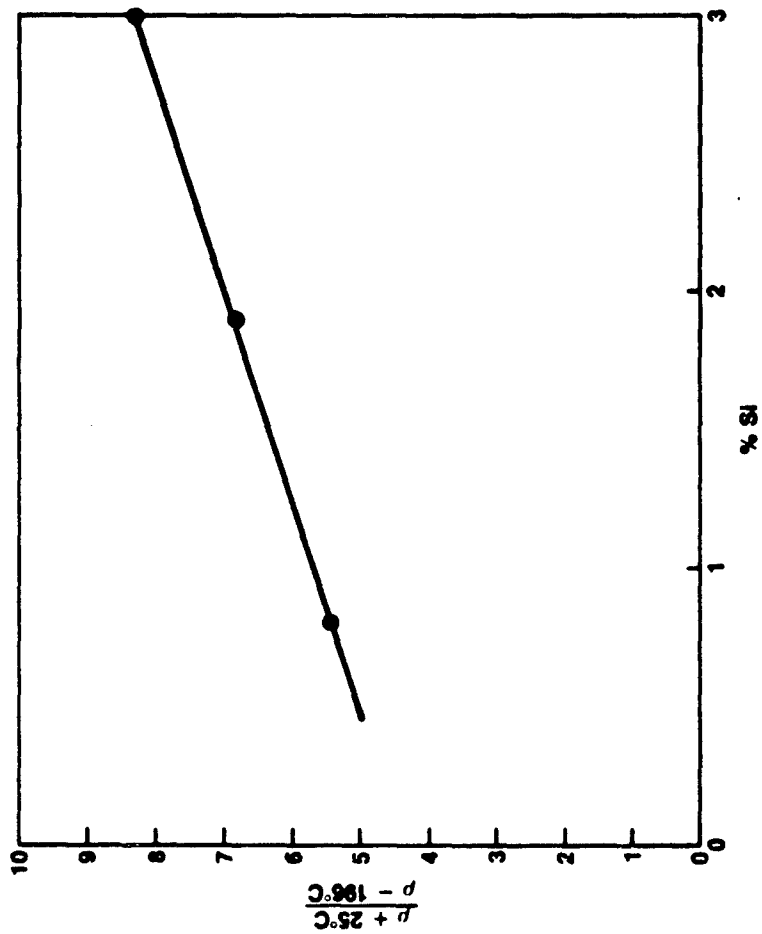
FIGURE 55. RESISTIVITY RATIO ROOM TEMPERATURE TO LIQUID NITROGEN TEMPERATURE AS A FUNCTION OF ALLOY SILICON CONTENT.

the resistivity ratio increases as the silicon content increases. This effect is believed due to the increased density of silicon nucleating sites as the silicon content is increased. Thus as the films are cooled the dissolved silicon has a greater opportunity to precipitate out of solution resulting in a purer aluminum lattice structure for the higher silicon content alloys. The purer aluminum lattice produces the higher resistivity ratios.

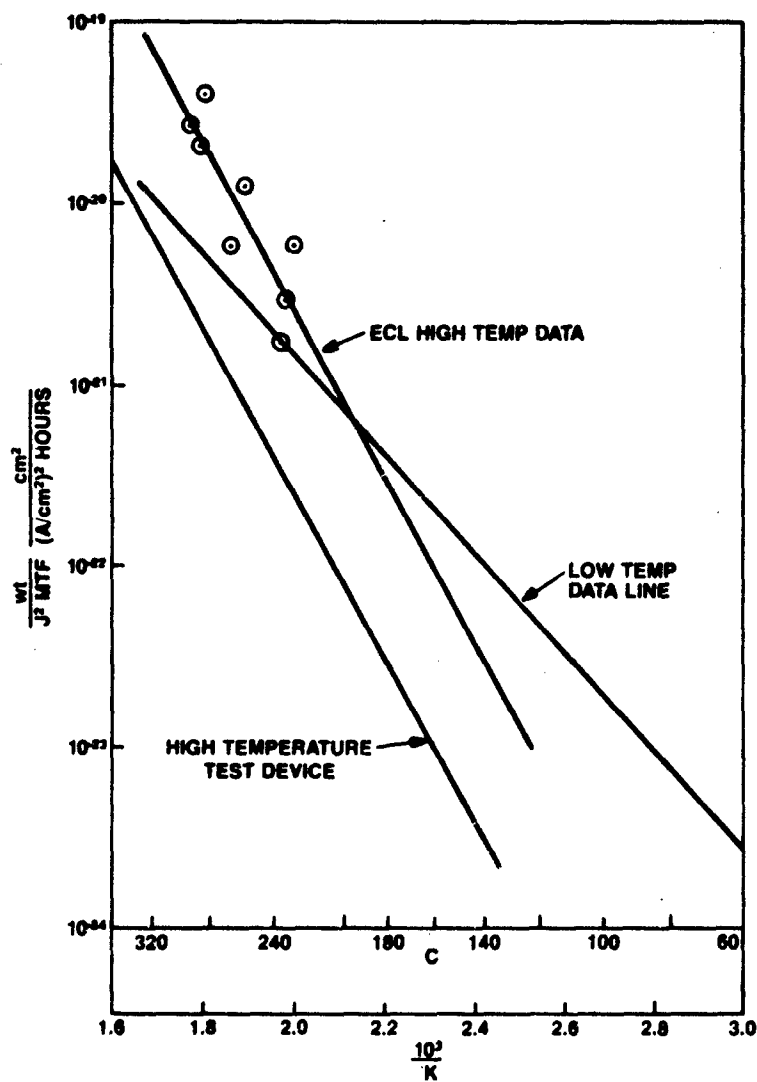
FIGURE 56. ECL DATA COMPARED TO DATA GENERATED BY THE HIGH TEMPERATURE TEST DEVICE AND LOW TEMPERATURE DATA
